CC5™ Bulk Rolls

Athens, Greece

CC5™ was used to line a bund and tank farm which required protection from further weathering erosion, and weed suppression.

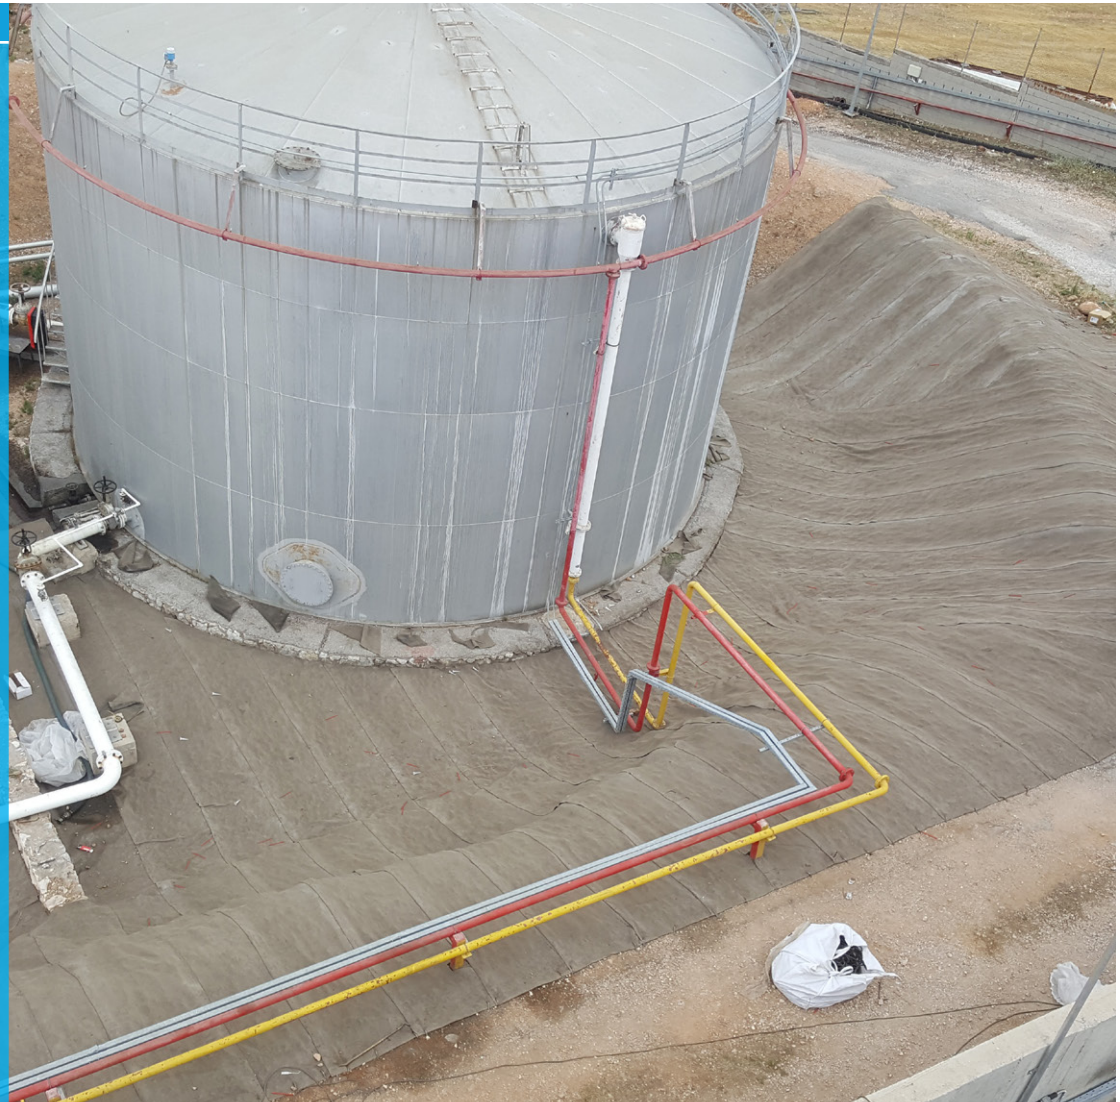
*The completed installation in Athens, Greece*

6,400m<sup>2</sup> of CC5™ were installed in 9 days by a team of 10 people, including 8 workers and 2 supervisors, in consistently high temperatures of around 45 degrees, on a site with restricted access. Elin Oil Hellenic Petroleum Company SA were impressed with the simple and rapid installation of CC as well as its immediate effectiveness after laying. The client and contractor also commented on the cost efficiency of CC, the ability to install the material with minimum and basic equipment, as well as the cleanliness of install compared to shotcrete. The use of CC will also mean the client's need to carry out regular maintenance on the site will be significantly reduced in future. They have now begun looking into the suitability of CC for further installations on their other tank farms around Greece.

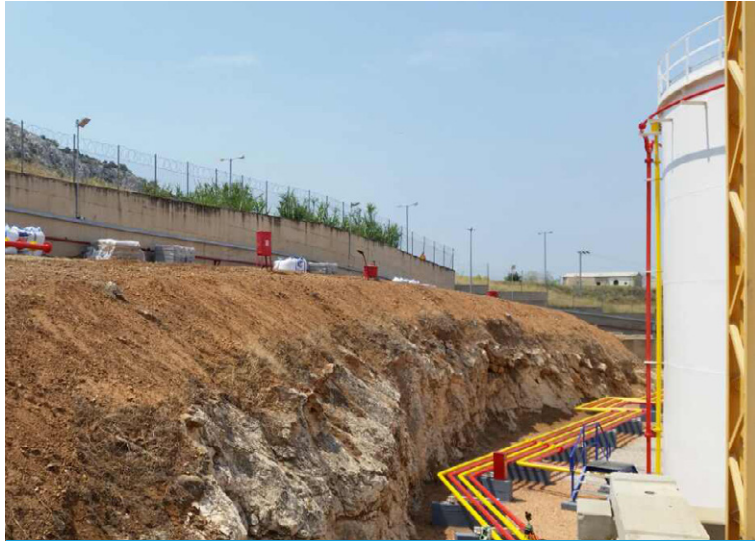
*The existing bunds had been affected by weathering erosion*

In September 2017, Concrete Canvas® GCCM\* (CC) was used for bund lining at a petroleum tank farm in Athens, Greece. The existing bunds of the petroleum tank farm were subject to weathering and erosion affecting the ground's integrity and failure of stability. The client required a long-term, durable and cost-effective solution to combat the issue. In addition, Athens is subject to extremely hot weather in summer months, with temperatures often hitting highs of 48 degrees, which was putting the heavily vegetated bunds in danger of causing fires. As a result, a weed suppression solution was also required to prevent fires on the site, which could be incredibly dangerous on a site containing highly flammable fuel. The chosen solution also had to be easily installed without interfering with the existing complex pipe infrastructure, while providing stability to infrastructure site-wide.

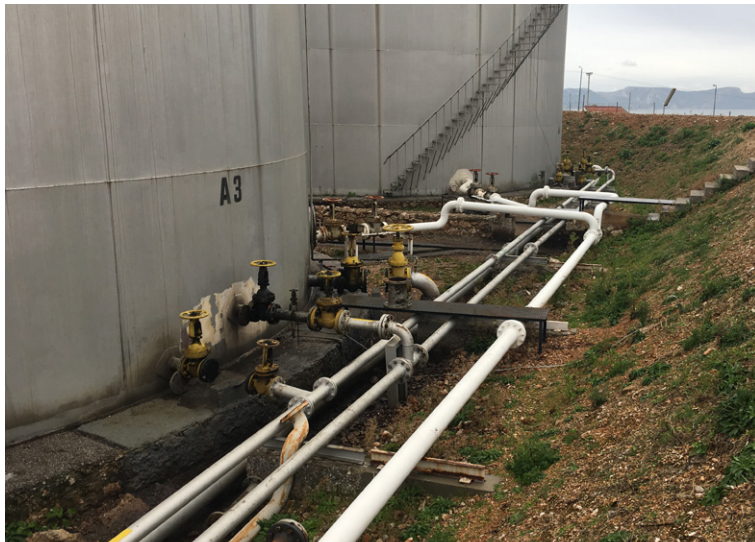
*A solution was required that could accommodate the complex pipework*

Infrastructure such as the petroleum storage tanks and pipework were easily accommodated due to the drape characteristics and flexibility of CC. The CC around the walls of the storage tanks, corners and other complex shapes from protruding infrastructure, was cut using hand tools, and where needed, an extra layer of CC was fitted around the item, then sealed. Once the installation was complete, the CC was hydrated using hoses attached to fire pipes. This was repeated three times due to the high temperatures of around 45 degrees on site, to ensure adequate hydration.

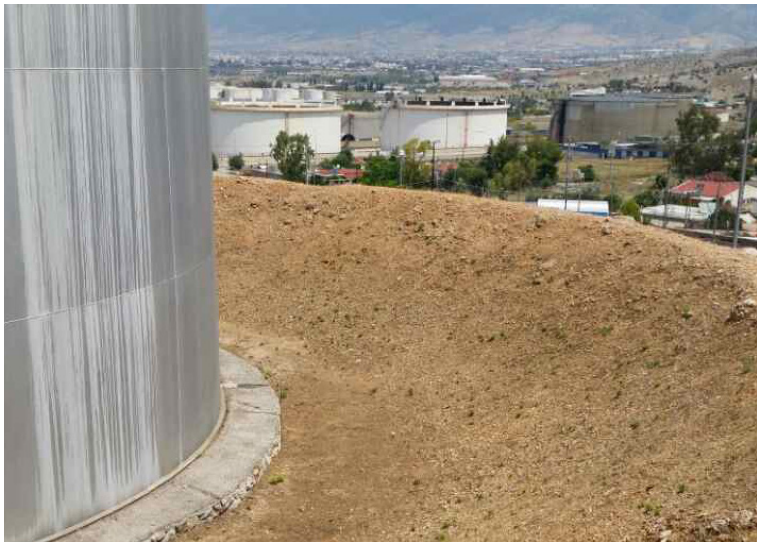
*All vegetation was removed prior to installation*

In preparation for the installation, all vegetation, rocks and debris were removed, and the ground re-levelled. Bulk rolls of CC5™ were then delivered to site, mounted onto a spreader beam and lifted using a crane to the crest of the bund slope. The CC was then unrolled, guided by two of the installation team, down the length of the slope, and two others continued to unroll the CC along the tank floor with the same continuous layer.

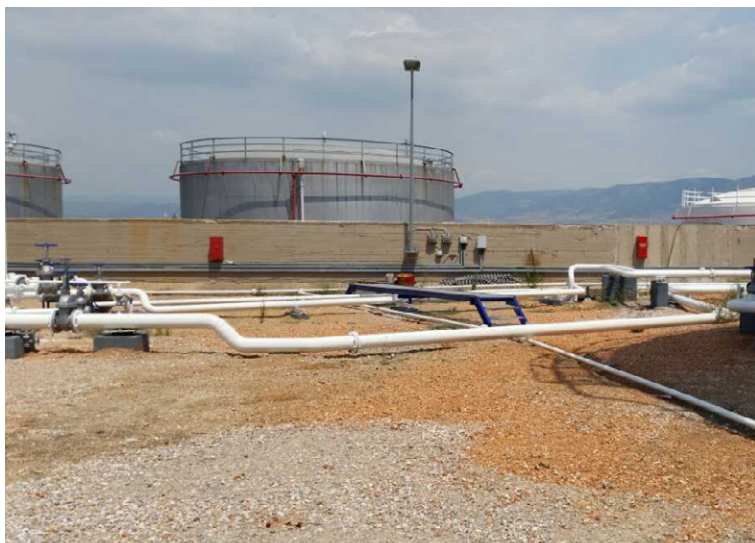
*And the ground levelled*

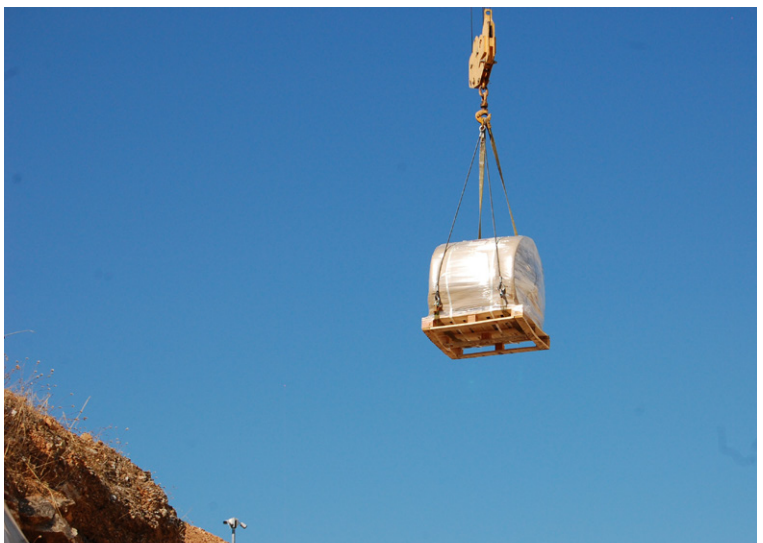
*CC5 was delivered to site in bulk rolls*

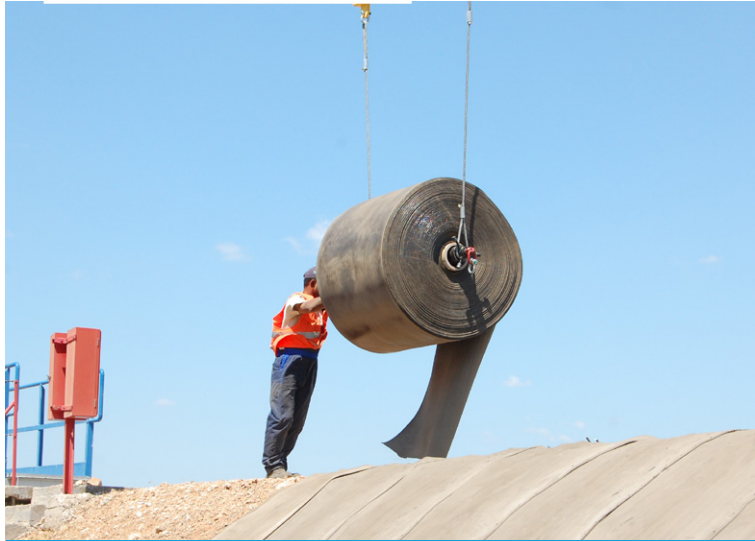
The CC was mounted onto a spreader beam and crane for easy deployment

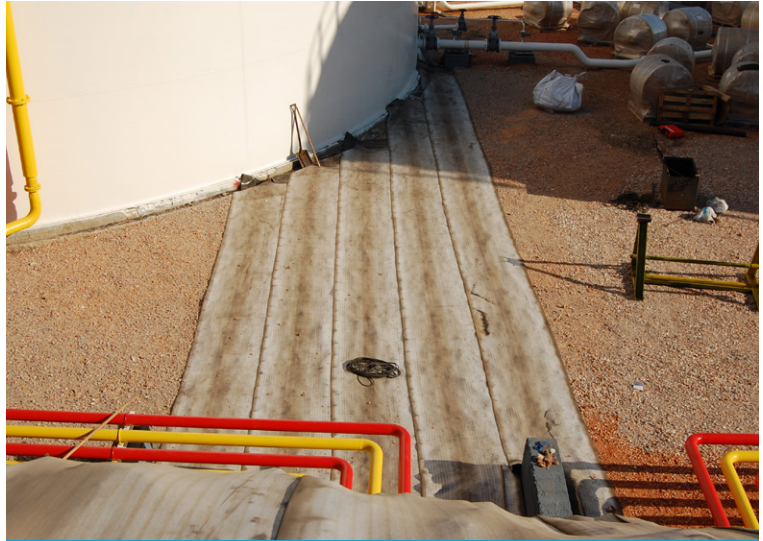
CC was unrolled down the slope and along the tank farm floor

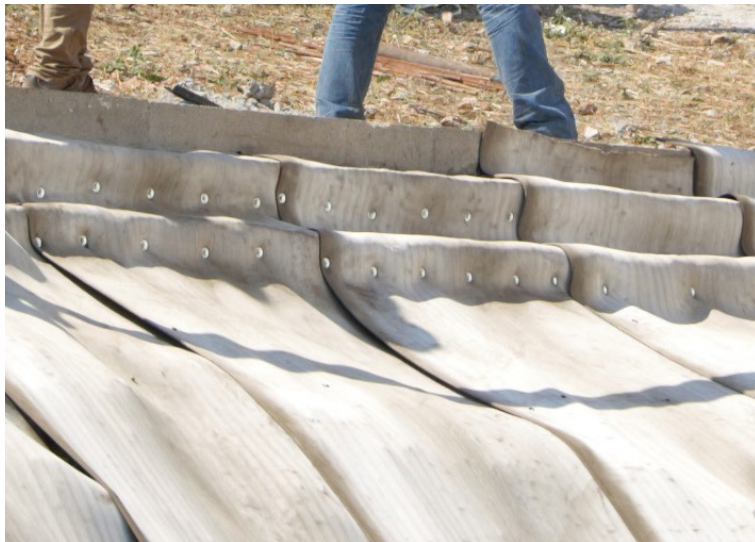
CC was fixed to a concrete slab at the crest of the slope with masonry nails

The CC was fixed at the crest to a concrete slab poured for this project using masonry nails. This process was repeated along the length of the slope, with additional layers overlapping by 100mm. Each overlap was sealed using Everbuild Clearfix adhesive sealant, and jointed using Hilti collated screws at 50mm intervals down the slope, and at 200mm intervals along the tank floor.

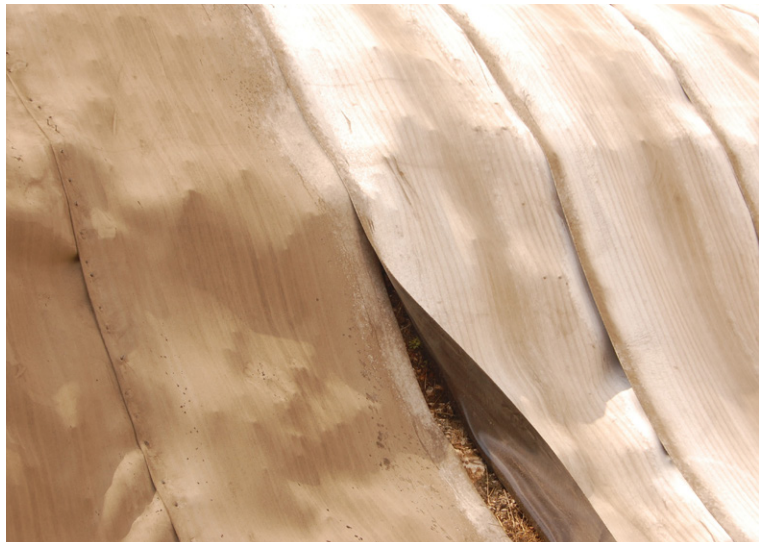
Additional layers were overlapped by 100mm

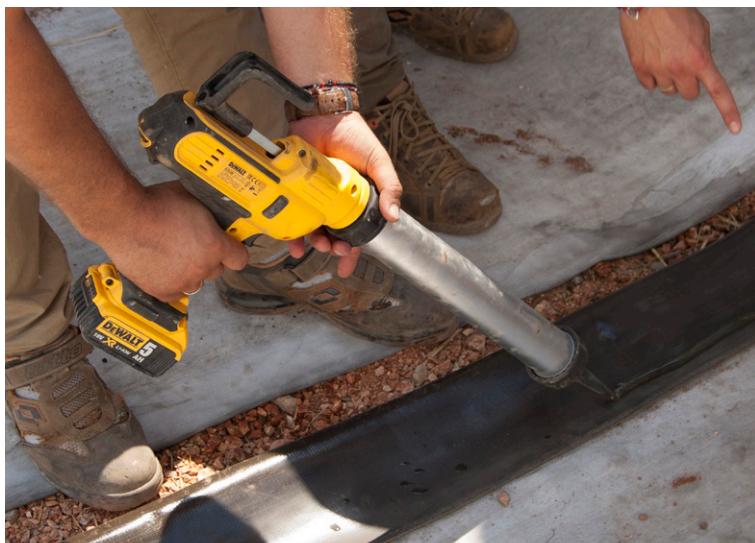
Overlaps of CC were sealed using Everbuild Clearfix adhesive sealant

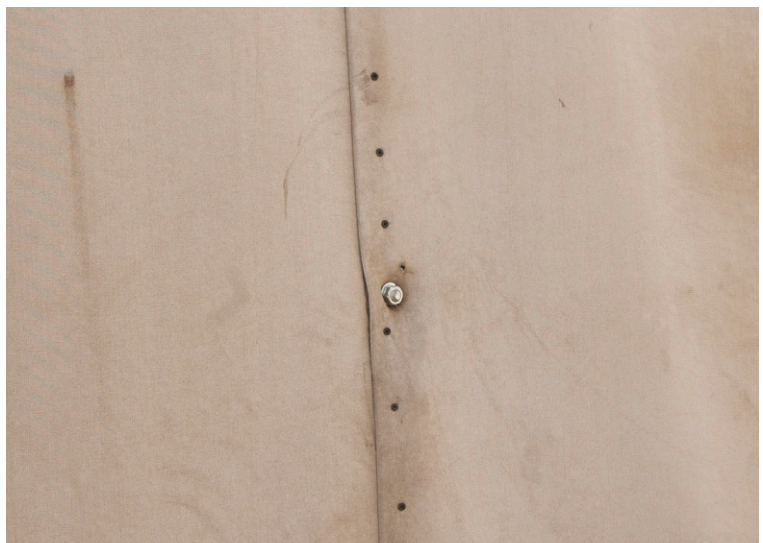
The CC was fixed and jointed using screws and anchor bolts

The slope's rocky surface was drilled and 12mm x 17mm anchor bolts were inserted along with 12mm x 250mm J pegs to secure the material to the slope, and then the floor surface. For the other end of the material, where it meets the wall, the same method was used, fixing the CC onto the existing concrete infrastructure using masonry nails.

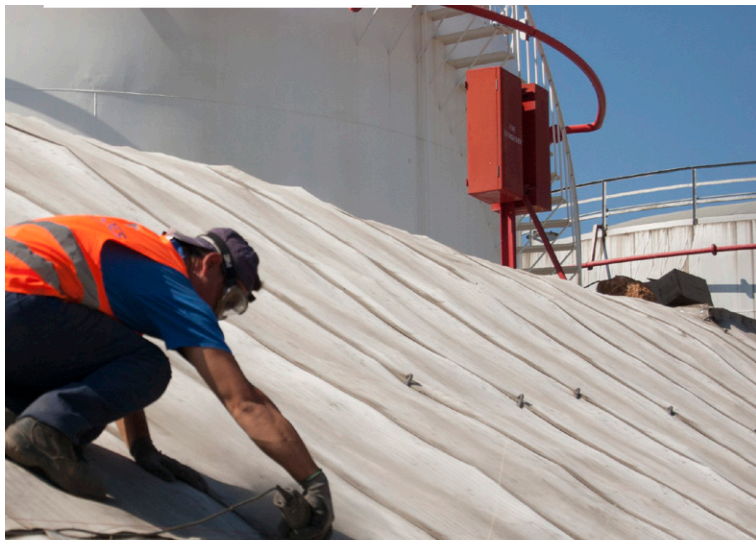
*J Pegs (seen right) were also used to fix the CC*

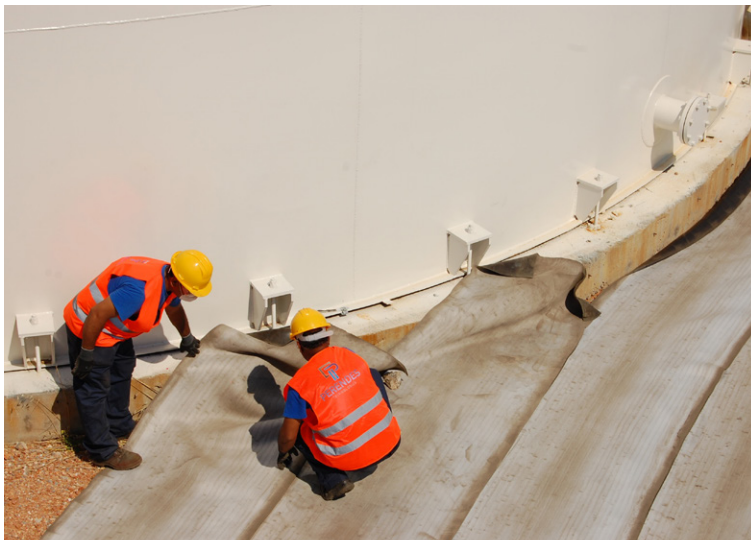
*CC was cut using hand tools to negotiate storage tanks*

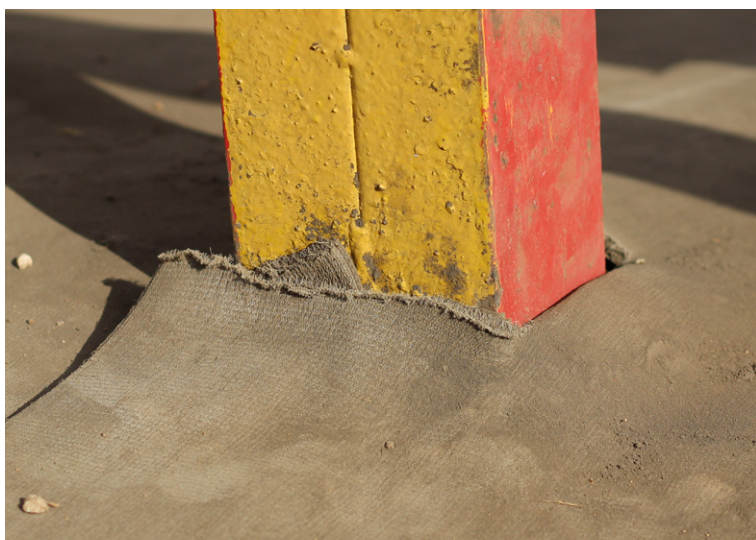
*The team also had to negotiate corners*

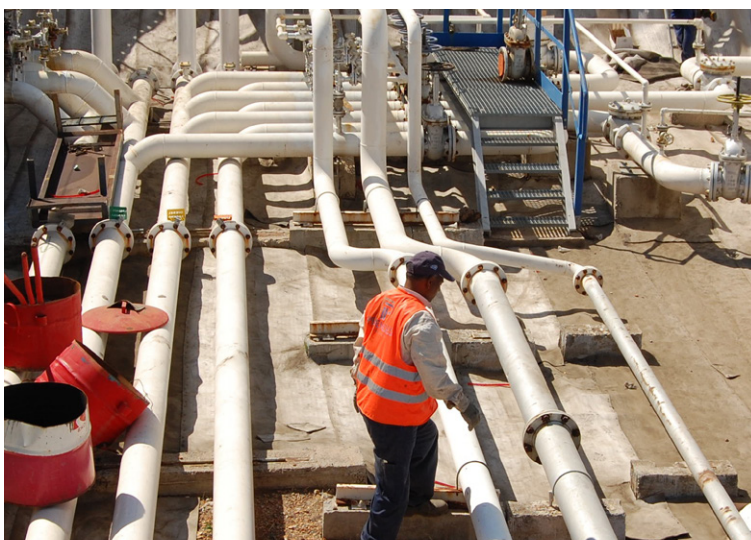
*CC easily accommodated for the complex pipework*

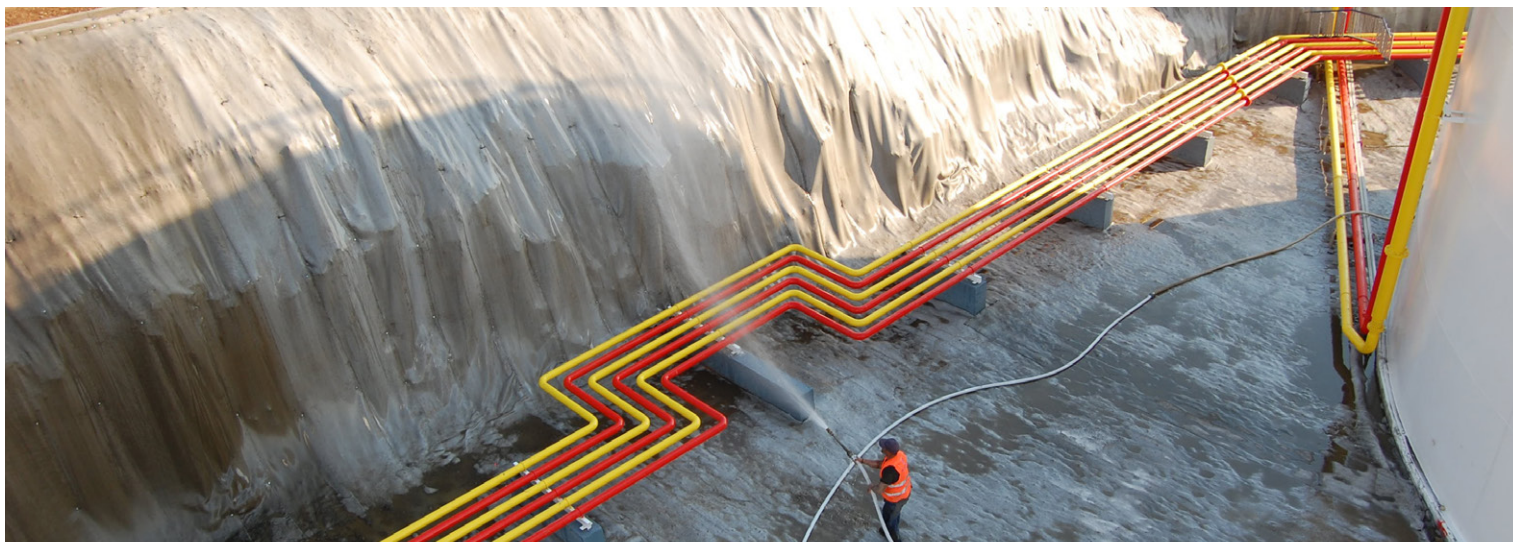
*The CC was hydrated using a hose attached to fire pipes*

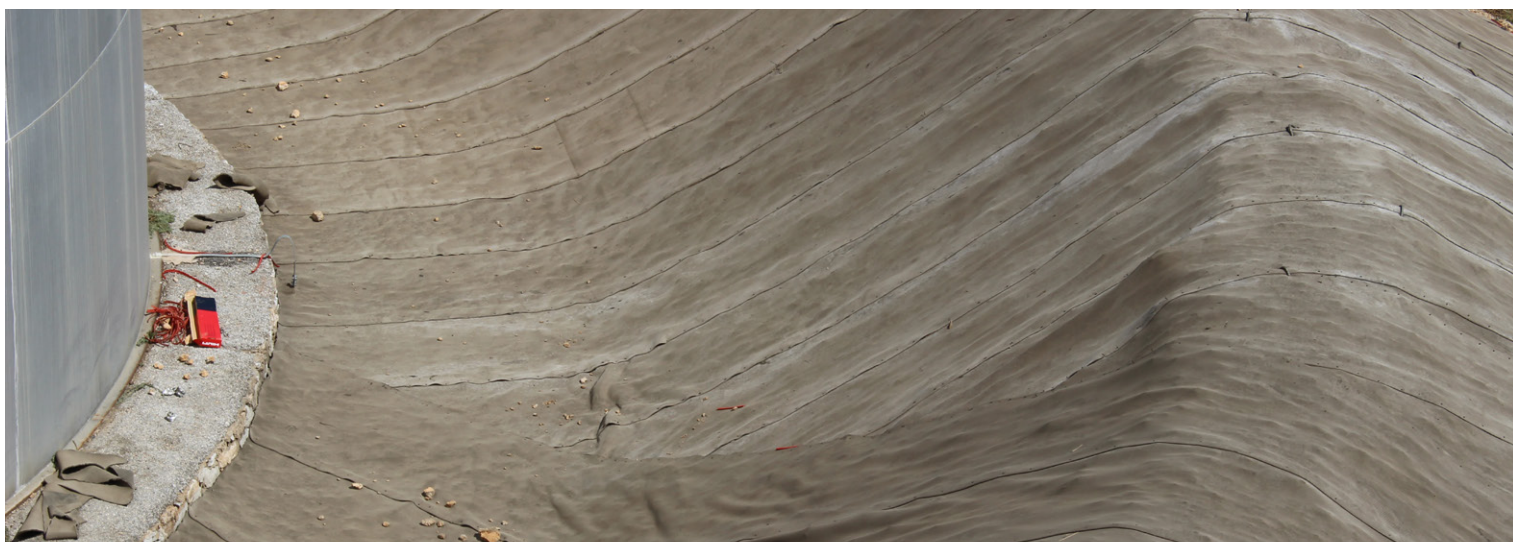
*Completed installation around a storage tank*

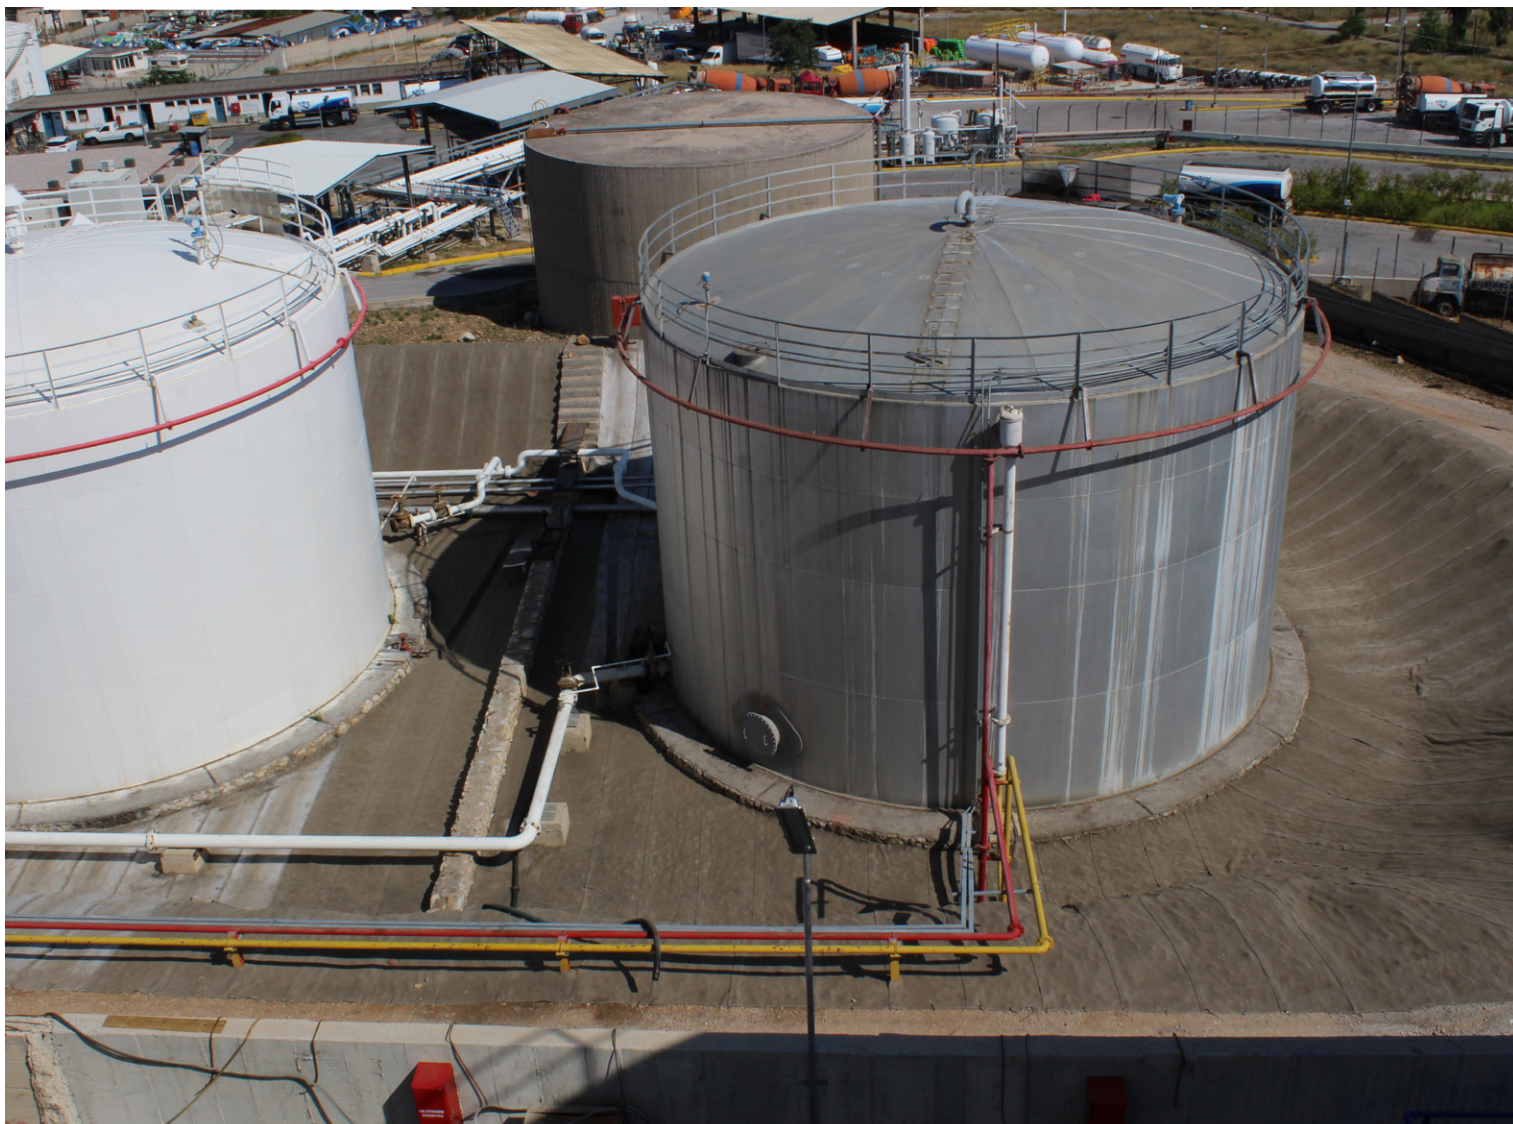
*The installation was completed in 9 days*
