CC8™ Bulk Rolls

Alcobendas Station,
Madrid, Spain

ADIF

Protection of railway
embankments on a high
speed rail line.

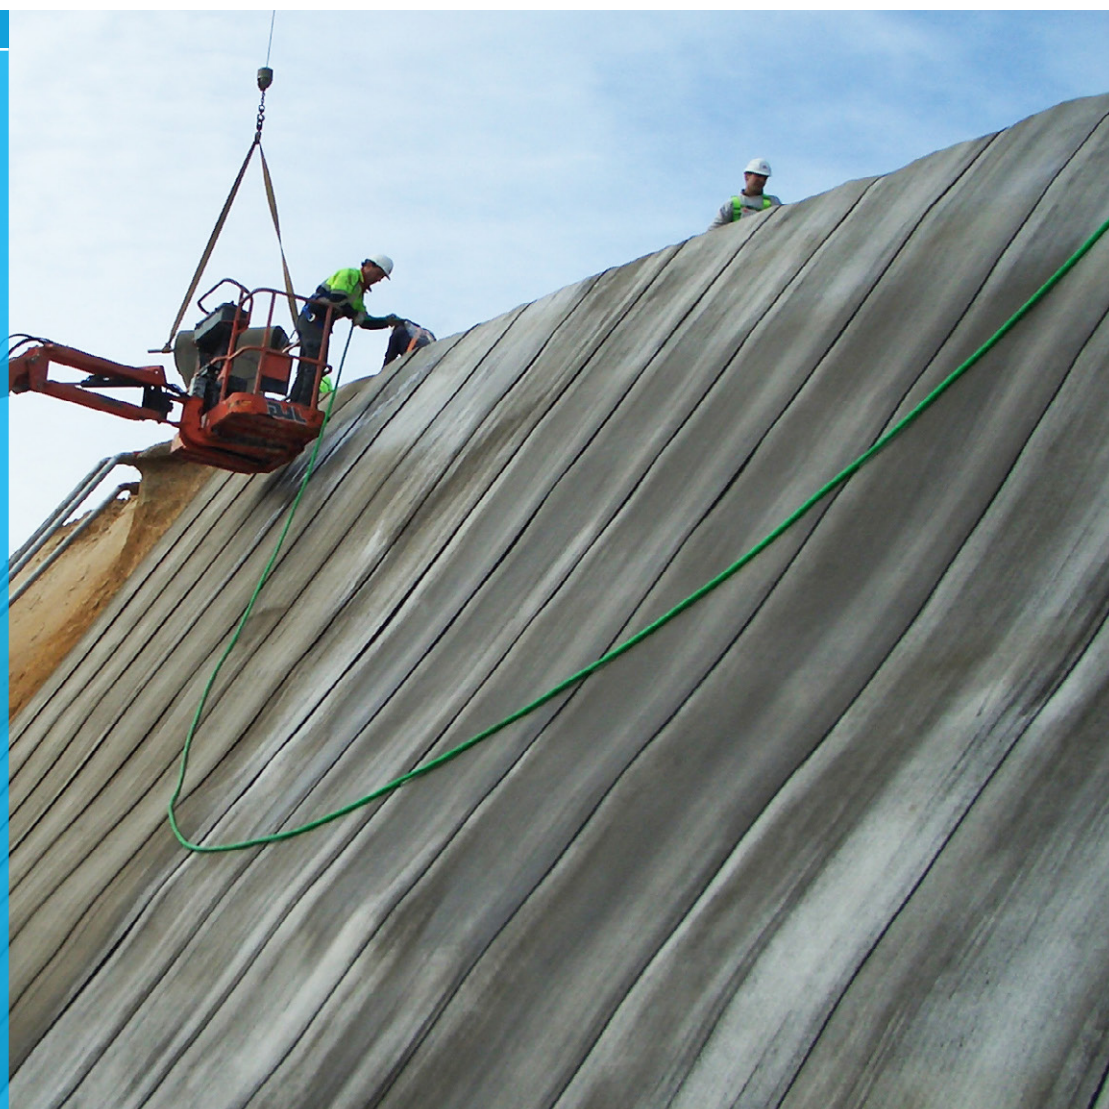
The installation at Alcobendas Station

In December 2010, ADIF, the Spanish authority responsible for railway infrastructure management, specified Concrete Canvas® (CC) GCCM* to be used as slope protection for a railway station in Madrid. CC was chosen to address years of erosion and instability issues affecting the entrance of Alcobendas tunnel station.

2500m² of CC8™ was specified and delivered on site in bulk rolls, which were dispensed from spreader beam equipment and plant. The CC8™ was fixed at the top of the 12m slope using galvanised steel pegs whilst adjacent layers of the material were screwed together. A shallow surface runoff ditch was formed at the toe of the slope.

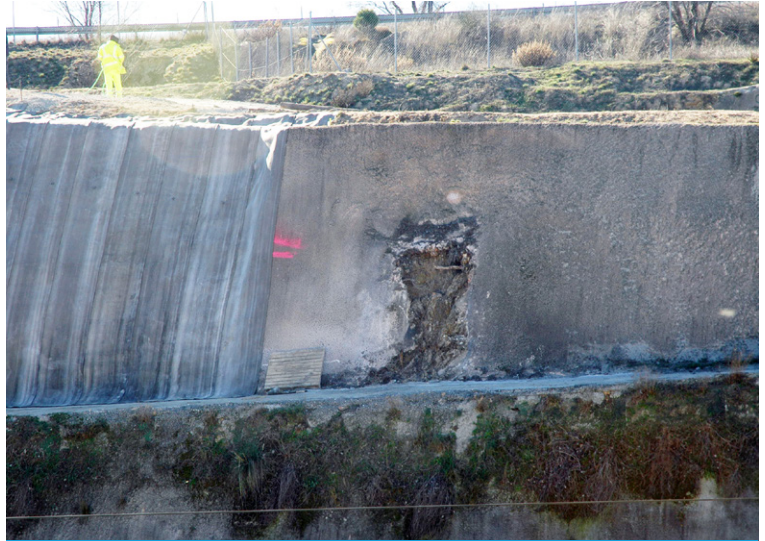
Erosion of the steep railway slope embankments had caused silting at the drainage pumps in the tunnel entrance. Shotcrete had been used twice previously but presented several problems with installation and durability.

Damaged gunite section from previous remediation work

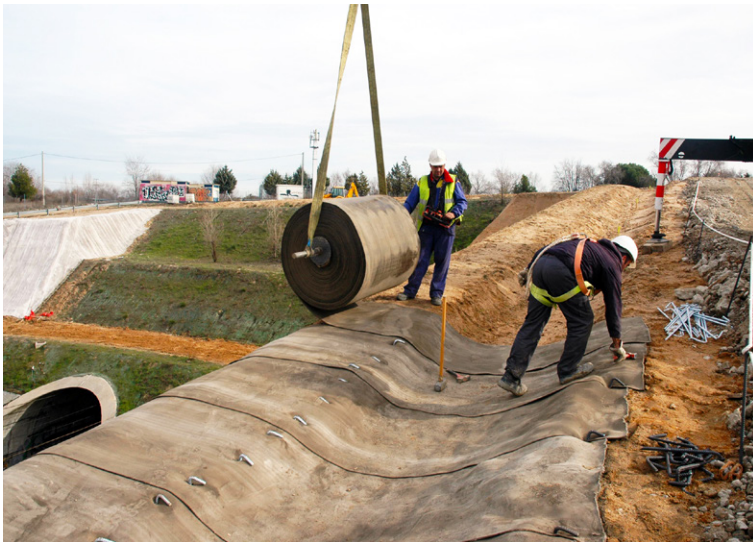
Dispensing from a bulk roll and fixing to top of slope using steel pegs

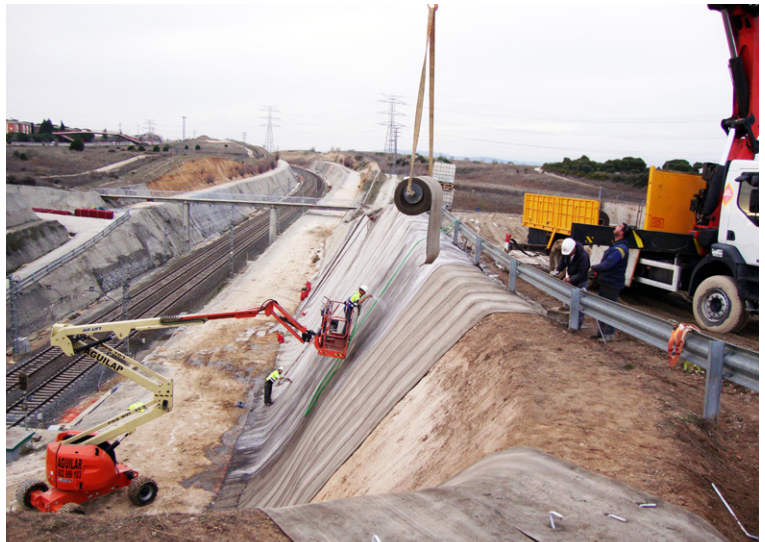
Hydration was given via a hose

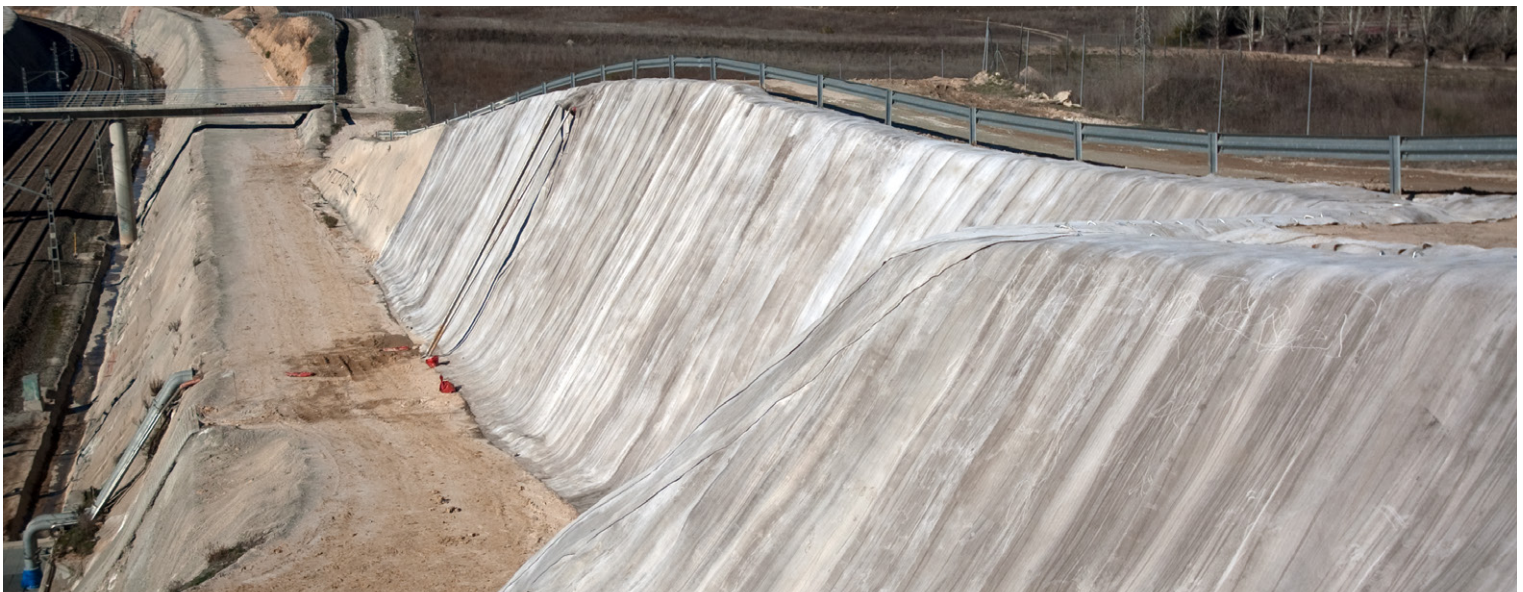
Installing at a rate of over 450m²/day, the project was completed in under a week and was 70% quicker to install than if shotcrete or gunite had been used.

The completed installation
